Property Repairs

May 10 2012

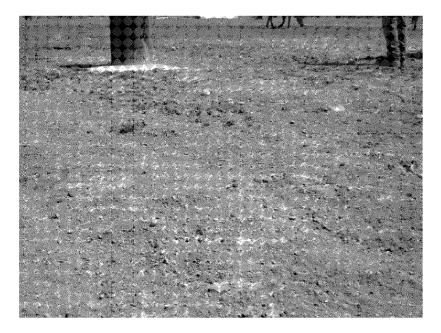
Disturbed/compacted soil by drilling equipment near well head

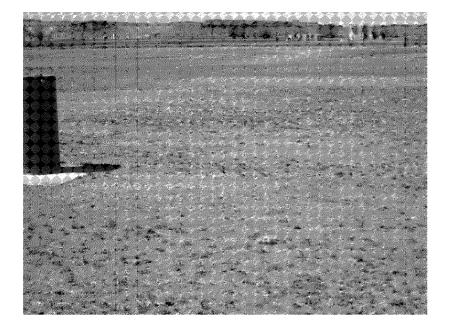
Disturbed area looking west
